PV power stations – fire hotbeds and fire tolls

Abstract. This article deals with photovoltaic power stations acting as possible fire hotbeds and simultaneously fire tolls. Main PV features defining fire risks of alone standing or on building mounted power station are discussed. Analyses described in main chapter are based on real case of a lightning strike. Divergence between direct lightning strike and close lightning strike is deeply illustrated and possible protections are discussed. Following paragraphs deal with fire rating and fire performance of particular PV panels, relevant dangers for acting firemen, extinguishing ways, particular fire progress and secondary hazards. The problematic is demonstrated on the base of experimental photovoltaic plant fire and real examples of injured panels.

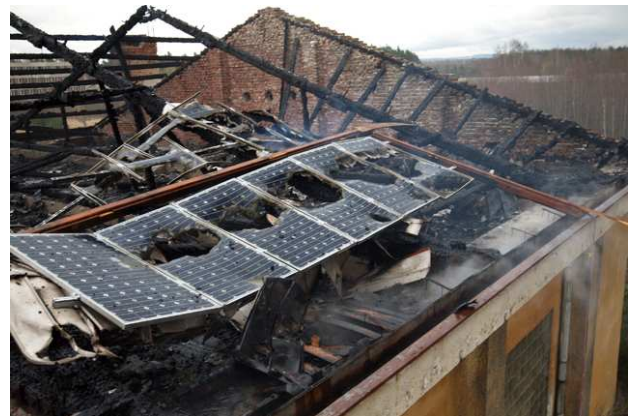
Events with natural background or specific human activities can, from our point of view, abstractedly on the motive lead in the consequence to the fire. PV power stations installed on buildings are more endangered than stand alone installations. The fire can be initiated inside the building independently of the plant components. Faulty electrical installations, defective house appliances or some misfortune events are good examples. On the other hand PV plant components can itself initiate the fire. Electrical component malfunctions or unpredictable result of natural events are typical events. Fig. 1 shows roof mounted PV power plant after fire of the building.

Fig. 1. Roof mounted PV power plant after fire.

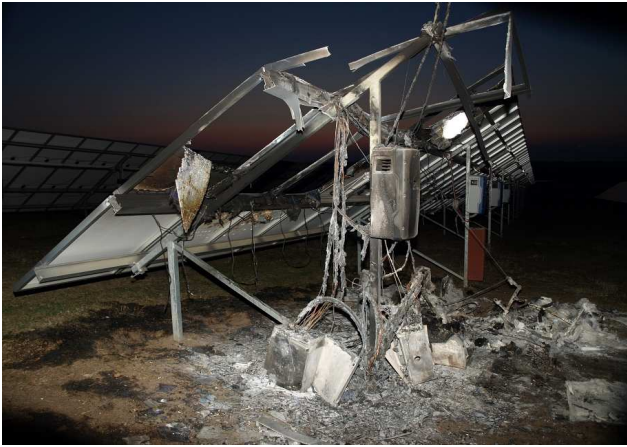
Large stand alone PV power plants are paradoxically smaller problem from the fire point of view. These systems are usually installed on a free area. No surrounding objects are to be affected or to affect the plant as demonstrated on Fig. 2 [3].

Fig. 2. Stand alone PV power plant after fire.

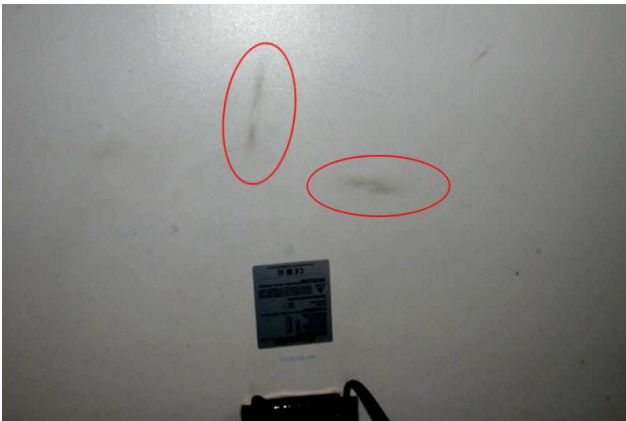
The other situation is much more frequent. Consequences are more difficult to identify, because the damage itself is caused only by some overvoltage. Although the semiconductor structures show serious malfunctions, the panel and surrounding objects are visually not affected or the particular degradation is almost not evident. Fig. 3 shows smoke traces on the backside of a panel damaged during lightning strike into close chestnut tree [3].

Fig. 3. PV panel damage after close lightning strike.

Subsequently a lightning hit into chestnut tree standing 15 m far from the industrial hall was located. Few superior branches were broken off and the trunk showed burn traces from the lightning download. Because the trunk had not been split, the lightning was classified as rather small. Close distance between the tree and the industrial hall caused that overvoltage had been induced between the supporting structure and wiring of the photovoltaic power plant [3].

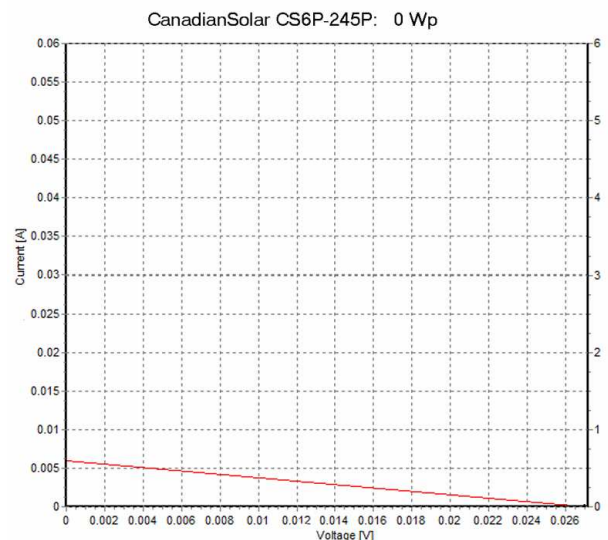
No usable VA-characteristic was recorded. Example measured in conditions very close to STC ($I_p = 983$ W/m², $t_p = 26.8$ °C) is demonstrated on Fig. 4.

Fig. 4. VA-characteristic of tested panel.

The nominal output voltage of the tested panel at STC is $U_{MAX} = 35.6$ V and nominal current is $I_{MAX} = 6.7$ A. The output voltage dropped almost to 0 V while the output current almost did not ascend above 0 A once the load was connected to the panel during the measurements. The panel was disconnected and shaded to cool down before this measurement to get as close to STC as possible for the particular experiment.

As evident from Fig. 4 maximum power point (MPP) was also not measured. The only sign of partial functionality is some low value of open circuit voltage recorded during additional measurements and presented in Table 1.

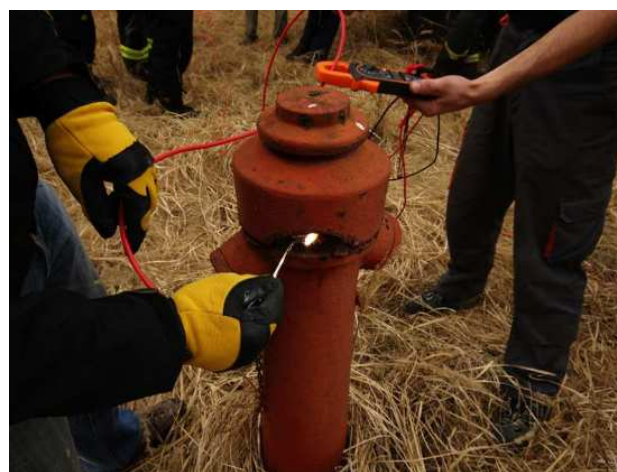
Fig. 9 presents sample measurement of secondary hazards – DC sparks. One of the output wires from PV string was grounded while the second one was freely and randomly used to ignite sparks on surrounding objects.

This situation often happens, when power wires are broken (burned or cut) and loosely hanging in the space. Any contact between the wires among each other can ignite a spark. Also random touch of one wire with some metal object (water drips, pipes, girders, sheetmetals, etc.) while the second wire is in synchronous contact with that object can initiate shortcut current and/or sparks.

Fig. 9. Sample of secondary hazards – DC sparks.

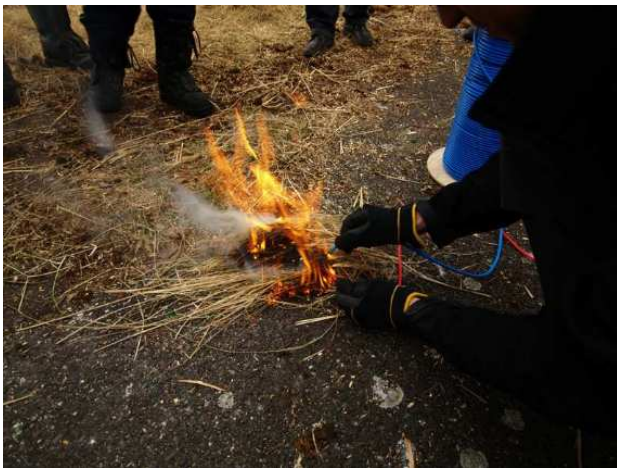
Although the ambient conditions were not ideal, experiments proved that these sparks have enough energy to initiate a fire of several typical flammable materials as shown on Fig. 10.

Fig. 10. Energy of sample DC sparks.

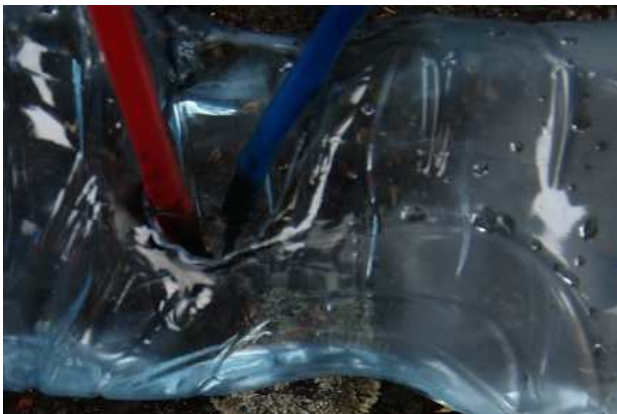
DC currents represent also another type of hazard that must be on mind while using water beam for extinguishing. Water electrolysis occurs in wet ambient, what means H_2 and O_2 production. Any higher H_2 concentration brings high explosion risk especially in environment with common initiating electric sparks. Fig. 11 demonstrates generation and caption of H_2 in some enclosed space (plastic bottle).

Fig. 10. H_2 generation in enclosed space.

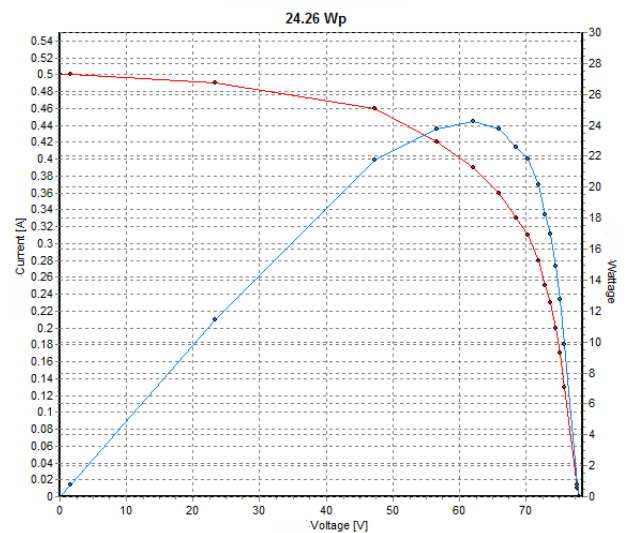
Measured VA and power characteristics of string 1 during the fire are presented on Fig. 11, Fig. 12 and Fig. 13. The partial power decrease on Fig. 12 can be explained with smoke shading the panels, while Fig. 13 shows zero output of damaged string.

Fig. 12. Sample VA characteristic (time 6:35 min)

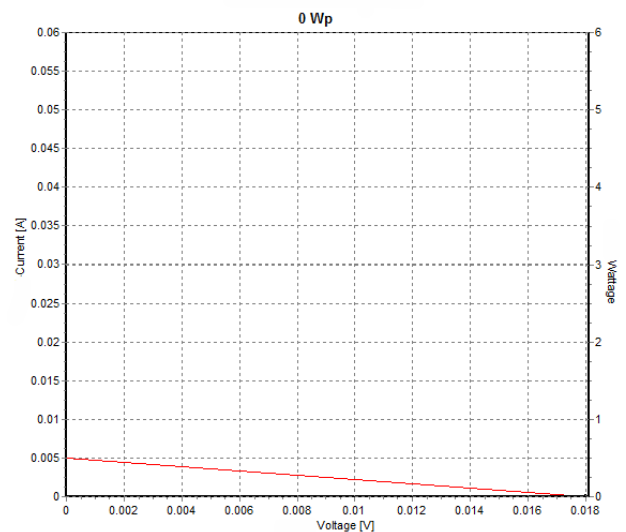
Fig. 13. Sample VA characteristic (time 10:12 min)

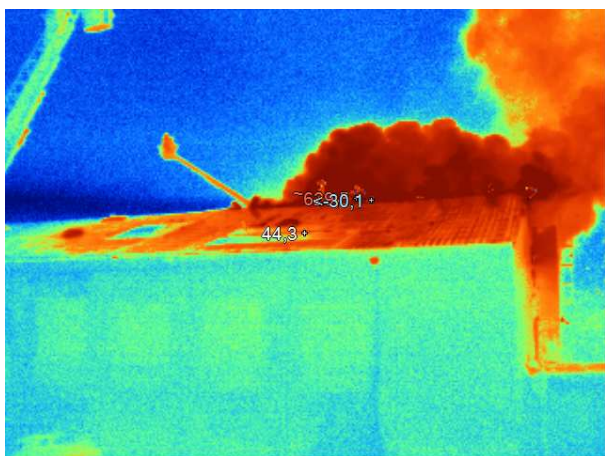
Sample thermogram from the fire progress (4:45 min) is demonstrated on Fig. 14. Panels on metal roof (middle of the picture) and panels on tiles (left part of the picture) are not affected yet, while panels on the tar roof are in the flames (upper right part of the picture).

Fig. 14. Sample thermogram (time 4:45 min).

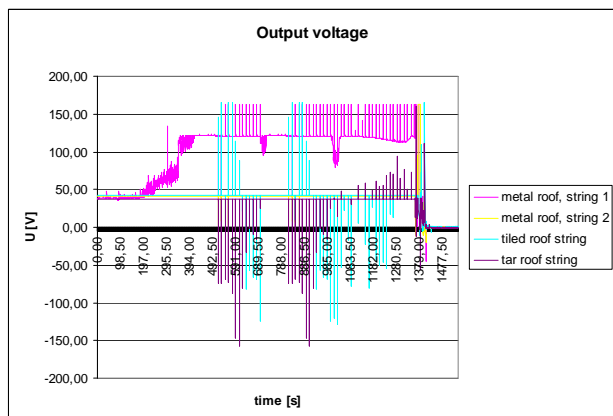
Fig. 15 shows the output voltage of all strings. It is evident that voltage fluctuated and even exceeded the nominal value. This unpredicted behaviour has simple explanation. Burned wires composed random temporary connections leading to overvoltage and even reverse voltage on the string output.

Fig. 15. Output voltage during the fire.
