## Transformer fault detection based on Raman analysis of the transformer oil (A case study)

M. Kadlečíková<sup>1</sup>, J. Breza<sup>1</sup>, J. Raditschová<sup>1</sup>, E. Vančo<sup>2</sup>, B. Butvinová<sup>3</sup>

### Abstract

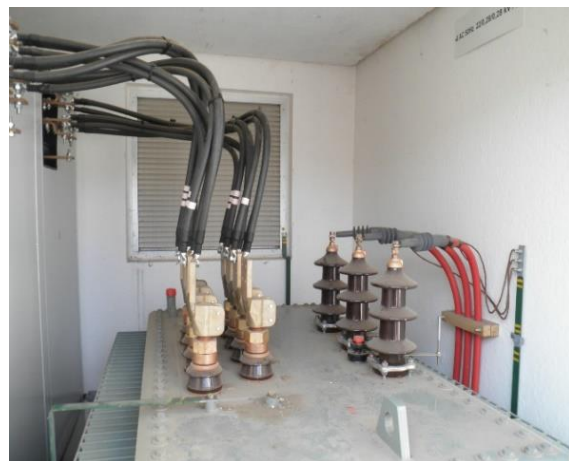
The fault on the transformer was manifested by an alarm from the digital protection system. At the time of the fault, the transformer had been in operation for 3.5 years. When looking at the transformer body from outside, no deformation or destruction of the transformer vessel was visible. There were no signs of oil leakage or other defects (such as bulging) on the welds or other parts of the vessel. There was no visible change in paint color as a manifestation of long-term elevated temperature, oxidation of metal parts due to ambient humidity or melting at the terminal and cable interface, color marks (color patterns) revealing overheating of joints due to assembly errors, and no signs of damage (blackening) of terminals or bushings on the LV and HV sides of the transformer cover (Fig. 1).

Fig. 1: LV and HV terminals and bushings on the oil transformer cover. The transformer was installed in the transformer part of a kiosk transformer station in a photovoltaic power plant. It is a three-phase oil transformer with a rated output of 1250 kVA for a nominal high voltage of 22 kV and 2×280 V low voltage. The three windings are Dyn1yn1 connected (delta connection on the higher voltage side, star connection on the lower voltage side, the clock angle is 1). The system is hermetically sealed in a radiator vessel and filled with a cooling and insulating medium – mineral oil. The container is naturally cooled by air. The winding materials are Cu and Al.

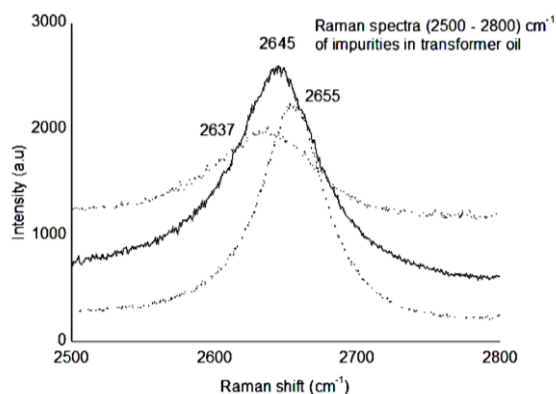
Fig. 3: Raman spectra of soot in wave number range from  $2500$  to  $2800 \text{ cm}^{-1}$

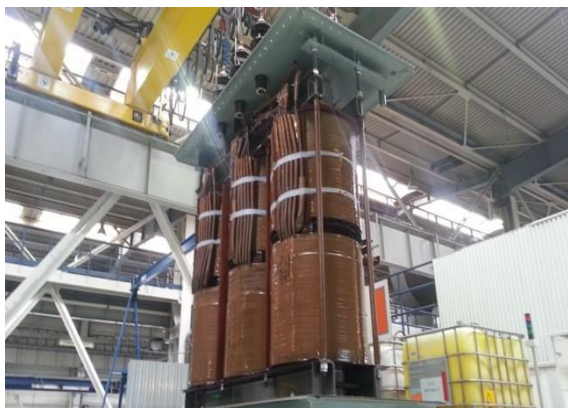
Fig. 4: Transformer pulled out of the oil vessel. The electrical insulation system of the transformer consists of combined dielectrics: mineral oil and paper.

After removing the transformer body from the oil sump (Fig. 4), damage to the high-voltage coil was first observed (Figs. 5 to 7). Figure 7 shows a locally burned HV winding. After complete disassembly of the transformer, damage to the magnetic circuit of the transformer (Fig. 8) and extensive destruction of the low-voltage coil (Figs. 9 to 12) were also found.

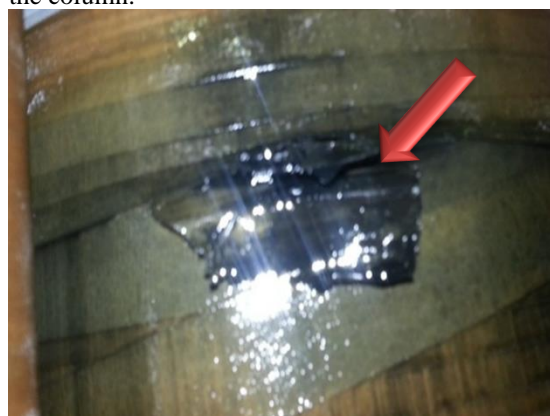
Fig. 6: Detail of the insulation of the HV coil of the transformer

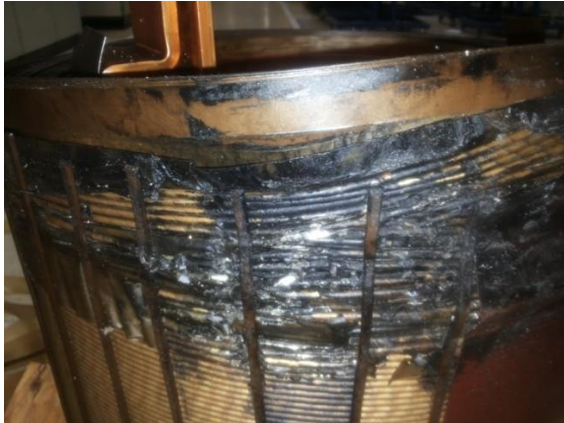
According to the appearance of the destruction of the transformer winding, the evolution of the event before the transformer failure was terminated by breaking the coil insulation of the winding and transitioning to an interturn short circuit. After the destruction of the winding insulation, the first coil short circuit probably occurred precisely in the part of the HV winding visible in Fig. 7.

Fig. 7: Exposed damaged winding of the transformer HV coil. The short circuit is located about 50 degrees from the busbar. The combustion plant has an irregular shape and a range from the surface to the first cooling channel.

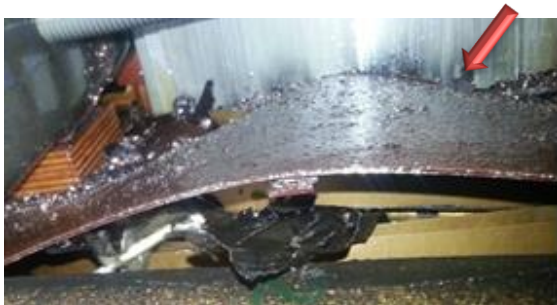
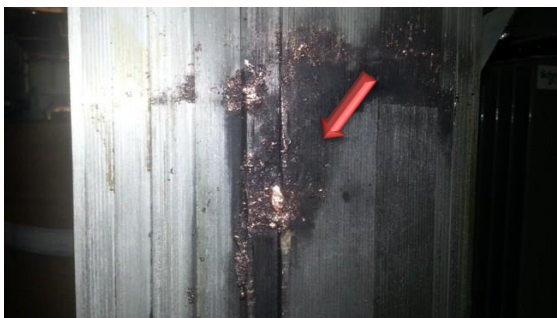
The burning electric arc in the LV coil near the transformer core (Fig. 8) was boosted up by the aluminum present, which reduced iron oxides and gave rise to liquid iron. At temperatures above 768 °C, iron loses its ferromagnetic properties. The melting of a portion of the transformer core is shown in the

photograph. Iron (Fe) has a melting point of 1528 °C and the transformer sheet used does not have a significantly different melting point from pure iron. It is obvious that local and short-term temperature at the level of the melting point of iron was reached in the arc, which damaged the transformer core.

Fig. 8: Arrows indicate the melting of the transformer's magnetic core.

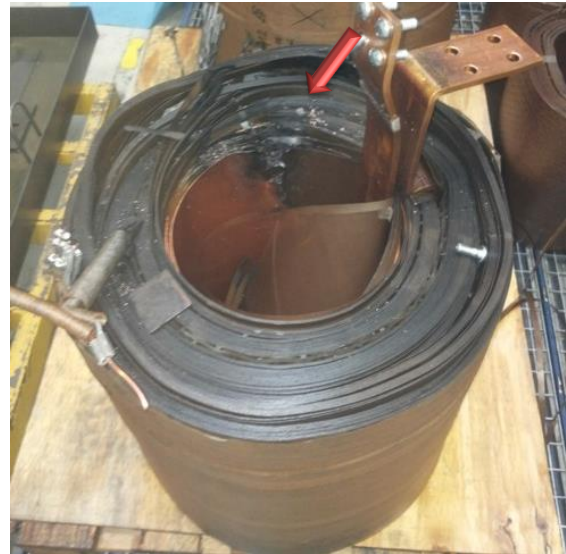
Fig. 9: LV coil foil winding. The short occurred at the top of the LV coil about 80 degrees to the right of the LV busbar. The destruction leads from the first layer of Cu conductors to the ninth. (It is possible that a developing fault in the HV winding has affected this adjacent LV winding.)

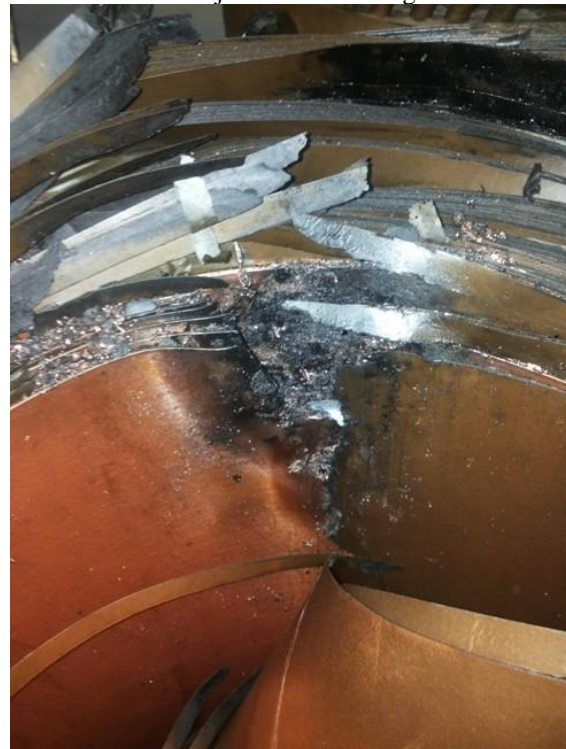
Fig. 10: Detail of the location of the interturn short circuit on the LV coil of the transformer. The interturn short went through 9 layers of the winding.

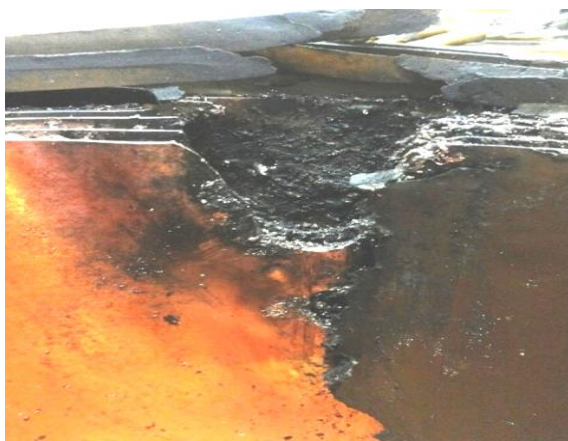
Fig. 11: Combustion site at the point of short circuit, where an electric arc has formed, which has led to deterioration of the insulation and melting of the winding conductor.

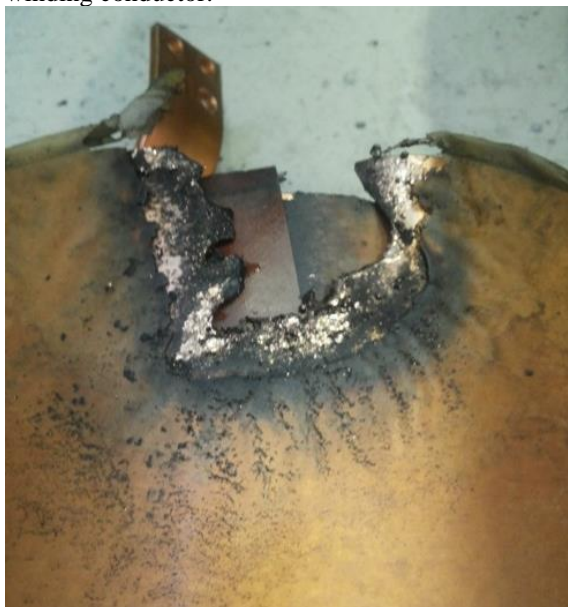
The interturn short circuit current passes through an arc between the coil conductors. The temperature reaches and exceeds the melting point of the conductor metal. Thus the electric arc burning at the interturn short circuit led to the melting of the winding conductor (melting point of aluminum is 660 °C, the melting point of copper is 1083 °C). The molten material of the LV coil winding can be seen mainly in Fig. 12.

Fig. 12: Detail of the molten winding of the LV transformer coil.
