# POST-IMPACT EVALUATION AT RC PLATES WITH PLANAR TOMOGRAPHY AND FEM

Deborah NERGER<sup>1</sup>, Falk HILLE<sup>1</sup>, Robabeh MOOSAVI<sup>1</sup>, Marcel GRUNWALD<sup>1</sup>, Bernhard REDMER<sup>1</sup>, Tino KÜHN<sup>2</sup>, Marcus HERING<sup>2</sup>, Franz BRACKLOW<sup>2</sup>

<sup>1</sup> BAM Federal Institute for Material Research and Testing, Berlin, Germany, [deborah.nerger@bam.de](mailto:deborah.nerger@bam.de)

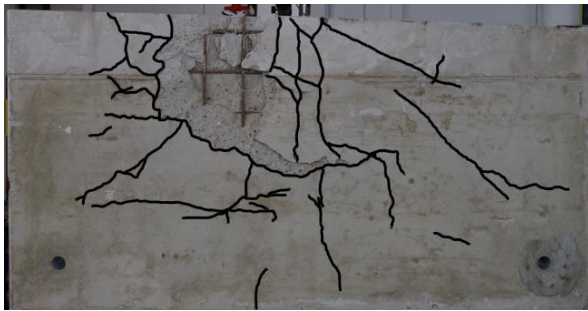
Fig. 1. Crack structure of the underside of S26P02

Fig. 1 and Fig. 2 show an example of the crack pattern of the surface and also of the interior of the plate (S26P02).

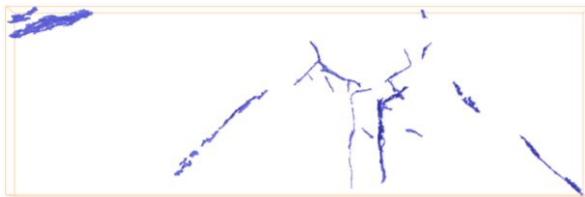
Fig. 2. Crack structure by planar tomographic investigation

The High Energy X-Ray Lab (HEXYLab) is located at BAM. The plate is investigated with the developed scanning regime. The subsequent reconstruction allows a very detailed examination of the damage of the complete plate with a crack detection algorithm.
