Determination PV Module Technical Condition

Abstract. The paper focuses on the determination of technical conditions and degradation of photovoltaic modules installed in grid-on operated photovoltaic systems in Ukraine and the Czech Republic. Detected malfunctions of PV modules are classified and Fault Tree Analyses (FTA) is created for particular PV modules. For assessment of the technical condition of the PV modules it is proposed to use residual resource index (RRI), that is being successfully used for determination of technical condition of transformers, breakers and synchronous generators. The main contribution is the method for the detection of photovoltaic modules condition with the use of a neuro-fuzzy network based on the experience of operational (maintenance) staff of particular plants.

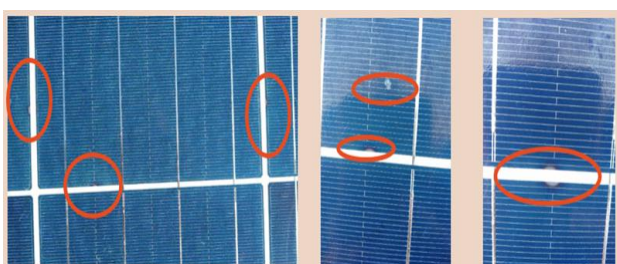
Fig. 2 shows typical examples of the hotspot - the most serious malfunction from detected. In the plant in Pisarivska there were 117 hotspots detected what means more than 25 % of all problems.

Fig. 2. Hotspots (Pisarivska, UKR, 2021).

Fig. 2 – 5 present malfunctions detected in winter 2021 on the photovoltaic array in ground-based PV plant "Pisarivska", installed in the eastern part of Ukraine. This PV plant realizes generated electricity at the "green tariff" (15.99 Eurocents per 1 kWh).

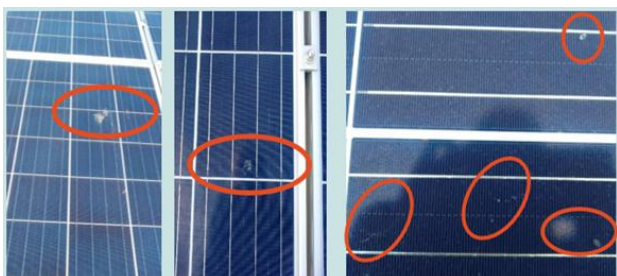
The most common was the less serious problem. Various signs of the local pollution (Fig. 3) were identified in almost 40 % cases. Although these cases are not serious they can lead to a massive biological or chemical corrosion with significant impact on panels.

Fig. 3. Local pollution (Pisarivska, UKR, 2021).

consequently resulting fastly decreasing resistance) as shown on Fig. 3.

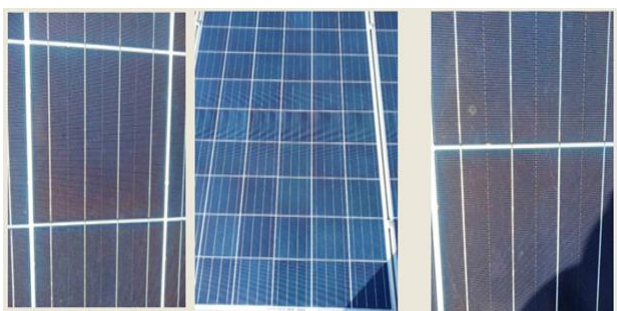
Typical behaviour of cell degradation affecting the EVA cover are demonstrated on Fig. 4. The most common feature of this problem is darkened or browned colour of particular area. This situation is also often conclusions from hotspots. Fig. 5 shows samples of mechanical defects (broken glass and sealing degradation).

Fig. 4. Cell degradation (Pisarivska, UKR, 2021).

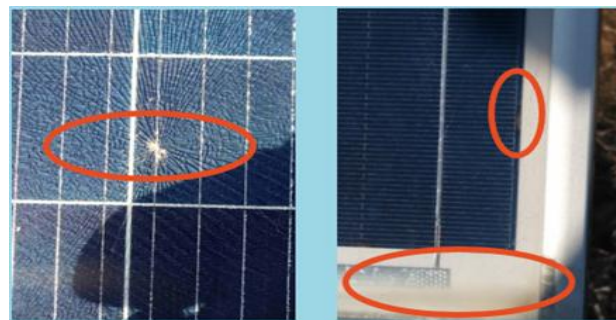
Fig. 5. Mechanical defects (Pisarivska, UKR, 2021).

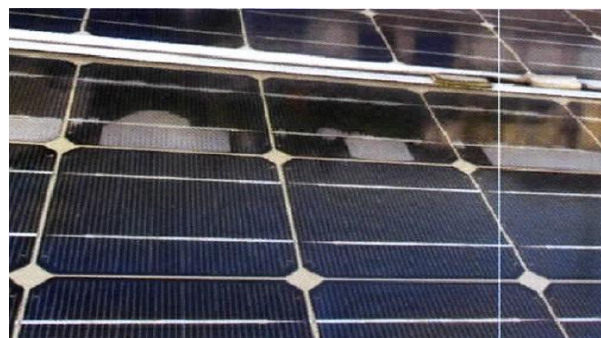
Following figures present examples of similar malfunctions detected between 2004 and 2021 on the photovoltaic plant installed on the university building in Pilsen (Czech Republic). This plant is one of the first commercial PV plants in Czech Republic and can serve as a contrapole of the relatively new Pisarivska plant. Fig. 6 shows very common delamination. This issue started to appear during 2018 after 14 years of operation.

Fig. 6. Example of a delamination (Pilsen, CR, 2018 - 2021).

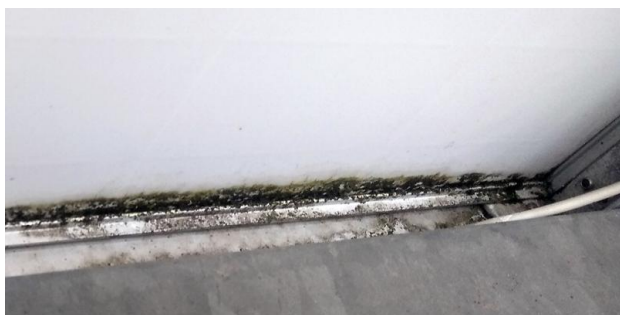
Another serious issue detected on Pilsen plant is demonstrated on Fig. 7. It is evident that back sides of the panels suffer with huge biological corrosion. Similar problems, but in a larger scale, were found also in Busanovice plant (CR) built on wooden structures.

These problems lead in praxis into serious commercial losses and also opens interesting technical problems. This malfunctions can affect (not just) positioning of affected panels leading to panel mismatch and further thermal overload resulting in shorter life of the panel. Also ohmic losses or shunt current can occur with the same results.

Fig. 7. Panel backside - biological corrosion (Pilsen, CR, 2021).

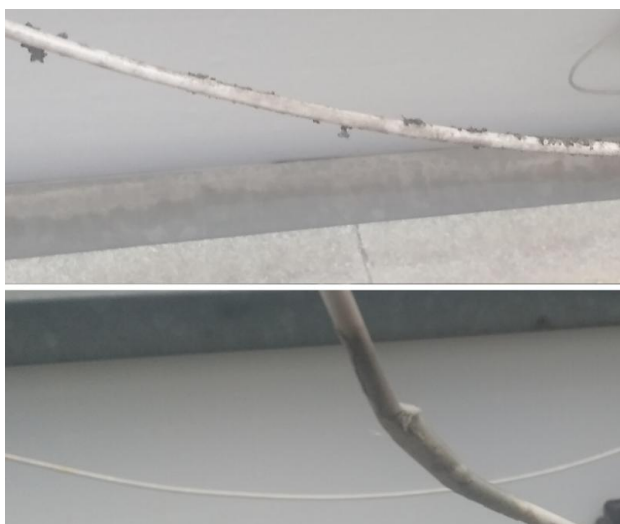
Fig. 8 demonstrates that loose cables suffer either with UV radiation degradation or with biological corrosion in the same way as the panels itself. Example is from Pilsen plant as well. Table II summarizes particular malfunctions detected on this system. The exposition to ambient conditions means serious stress for used materials.

Fig. 8. Cable degradation and corrosion (Pilsen, CR, 2021).

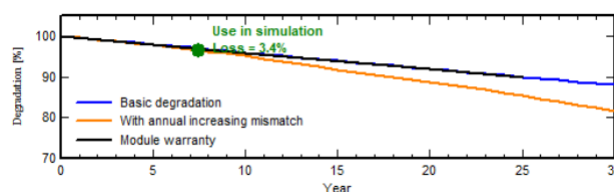
Shape of the correction curve is presented on Fig. 9. Accuracy of this correction curve was compared to real measurements on Pilsen plant from 2009 to 2018.

Fig. 9. Aging correction curve.

Continuous measurements on the plant are used as the input for aging simulations and analyses in 20 years period. Results of the simulation in PV Syst are presented in Table III and further could be used as a correction curve in the FTA.

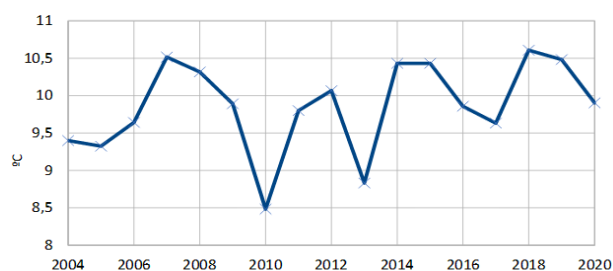
To verify the accuracy and trueness of this comparison, respectively to avoid variations caused by changeable ambient conditions, the results were confronted to real meteo data. Fig. 10 shows average temperatures and it is evident that the variations in the Table IV correspond the real situation and can be classified as accurate.

Fig. 10. Average temperatures (Pilsen, CR).

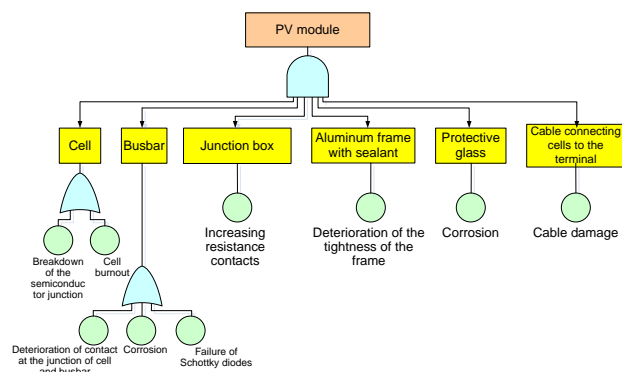
FTA of a common PV power plant is built taking into account the data in Table 1, Table II and the correction curve. Basic chart of the tree is demonstrated on Fig. 11.

Fig. 11. FTA of PV power plant

If take into account, that the malfunction of each elements (noted in Table 1) results in a failure of the PV module (Fig. 11), then the total RRI PV modules is calculated using (2):
