PV power stations – fire hotbeds and fire tolls

Abstract. This article deals with photovoltaic power stations acting as possible fire hotbeds and simultaneously fire tolls. Main PV features defining fire risks of alone standing or on building mounted power station are discussed. Analyses described in main chapter are based on real case of a lightning strike. Divergence between direct lightning strike and close lightning strike is deeply illustrated and possible protections are discussed. Following paragraphs deal with fire rating and fire performance of particular PV panels, relevant dangers for acting firemen, extinguishing ways, particular fire progress and secondary hazards. The problematic is demonstrated on the base of experimental photovoltaic plant fire and real examples of injured panels.

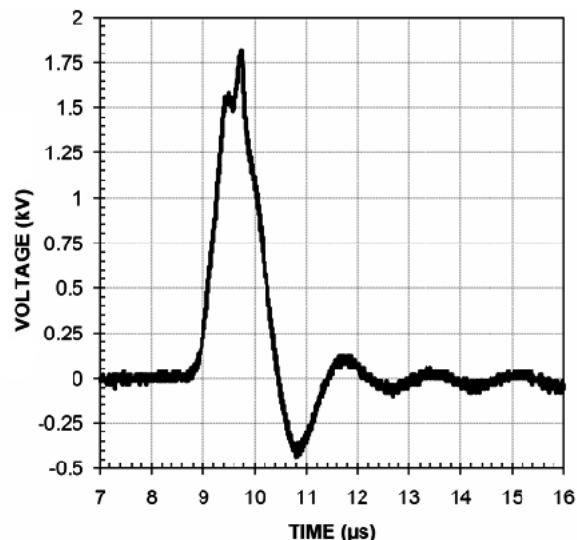
Sample waveform printscreen of generated HV pulses for $U_p = 2$ kV is demonstrated on Fig. 5.

Fig. 5. Sample pulse 2 kV (EM Test VCS 500).

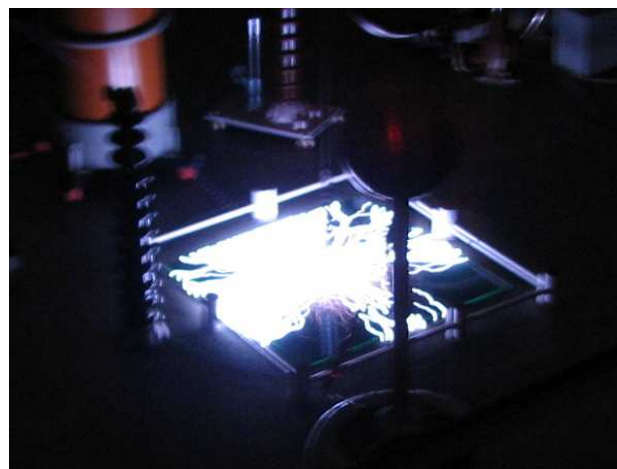
Table 2 and Table 3 show that no measurable panel damage was detected on VA characteristics. That could be explained with insufficient energy of generated pulses although the discharges produced very dramatic visual effects as demonstrated on Fig. 6.

Fig. 6. Sample pulse 600 kV (Heafely generator).

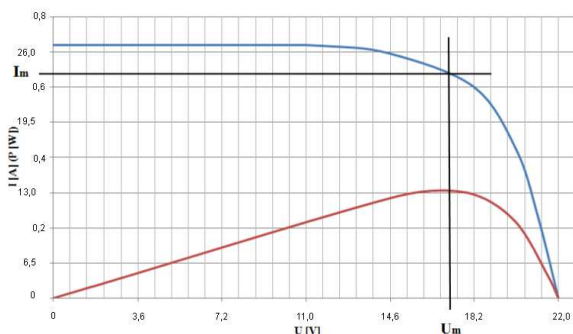
Sample VA and power characteristic after all measurements is displayed on Fig. 7. No deformation similar to Fig. 4 is evident and the values are proper to

nominal listed in Table 2. Also no visual damage similar to Fig. 2 was detected.

Fig. 7. VA characteristic after all tests.

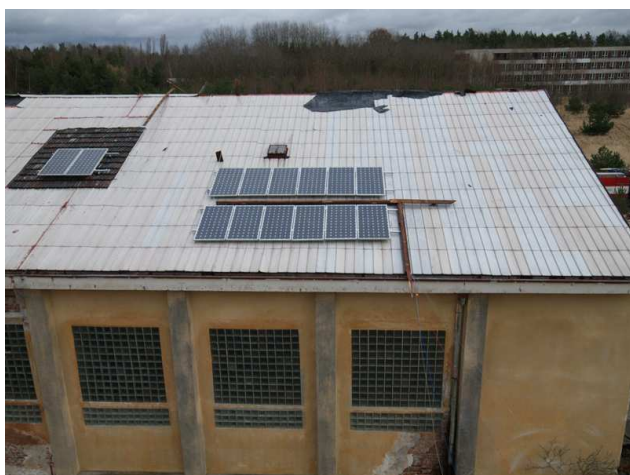
Experimental PV plant was built on the roof of an old military building determined to be demolished. Configuration of the experimental plant on the building roof is displayed on Fig. 8.

Fig. 8. Experimental PV plant configuration.

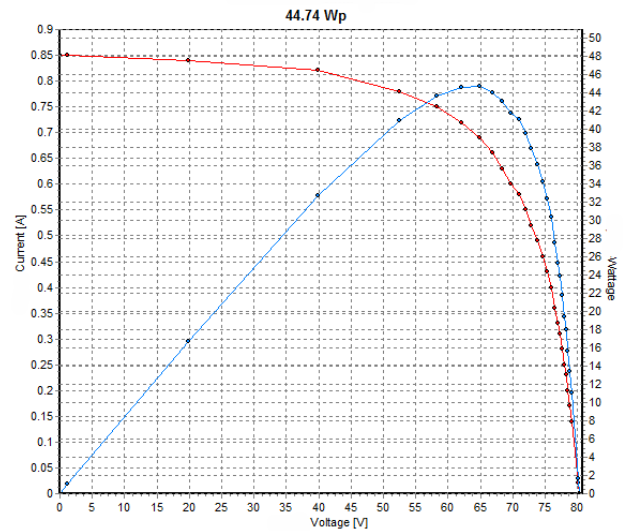
Measured VA and power characteristics of string 1 during the fire are presented on Fig. 11, Fig. 12 and Fig. 13. The partial power decrease on Fig. 12 can be explained with smoke shading the panels, while Fig. 13 shows zero output of damaged string.

Fig. 11. Sample VA characteristic (time 0:00 min)
